FERRY VESSEL SIZE COMPARISONS

FEBRUARY 2011

State Route 21/Keller Ferry-Vessel Replacement

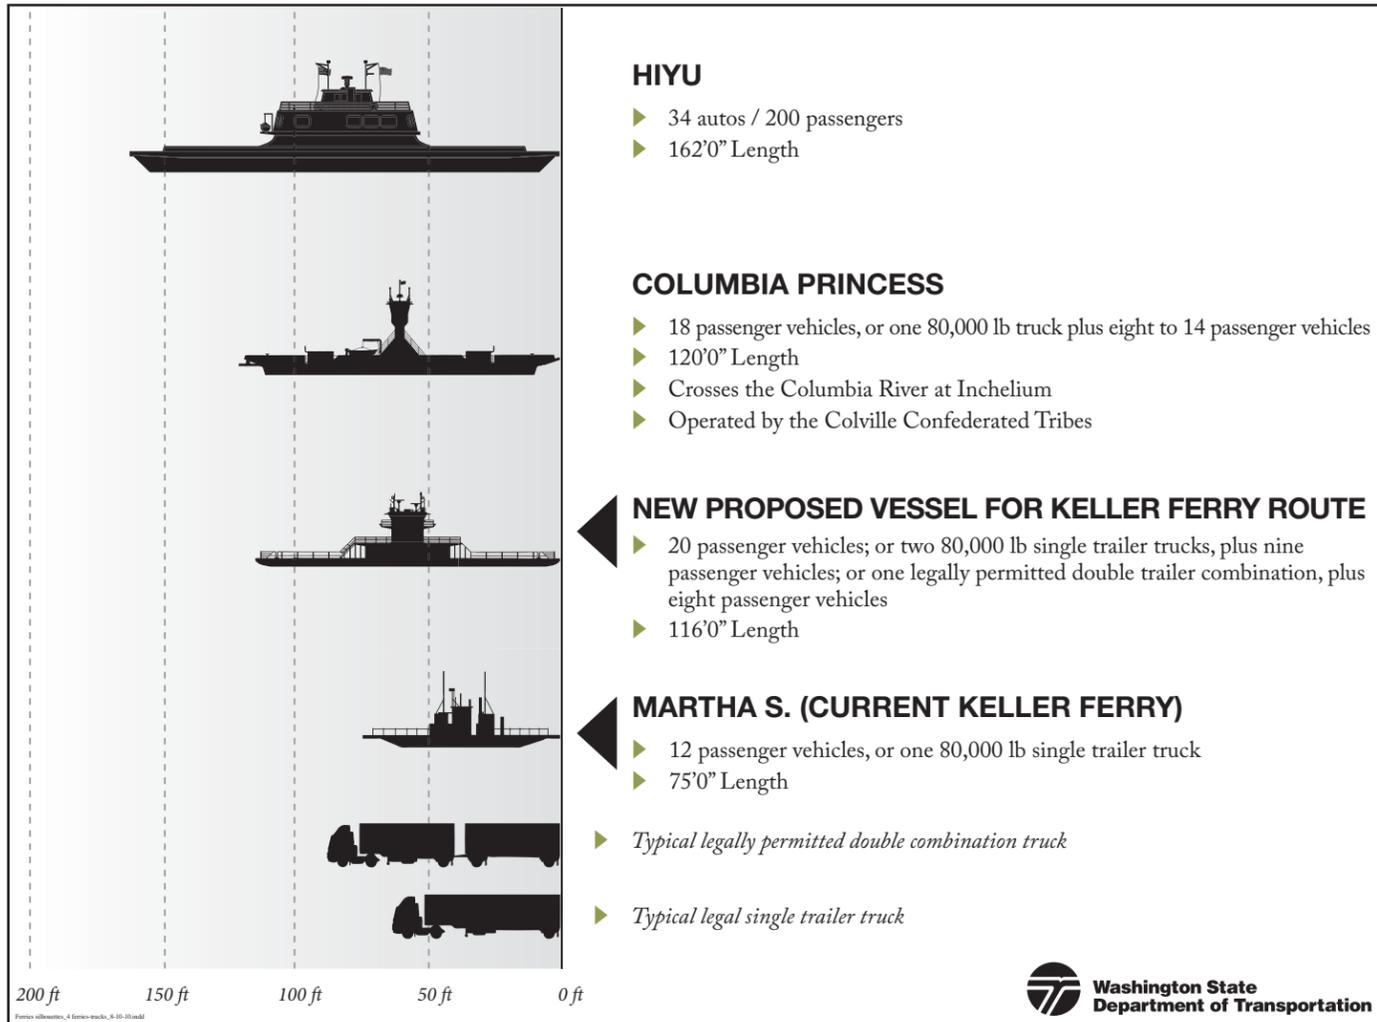
- The "Hiyu" diagram is used to provide a scale reference to the smallest vessel in the Puget Sound/Washington State Ferries Division fleet. The "Hiyu" is pressed into service only as a "spare" when other vessels are unavailable.
- The "Columbia Princess" is used on a free ferry route operated by the Colville Confederated Tribes under contract with the Bureau of Indian Affairs. That route crosses the Columbia River about 50 river miles upstream from the Keller route.
- The "Martha S." with only single compartment damage stability is currently grandfathered under US Coast Guard regulations to carry an 80,000 lb. gross weight truck.
- Walk-on passengers are permitted on the Martha S., Columbia Princess, and the New Proposed Vessel; however, none of these vessels have inside accommodations for passengers.

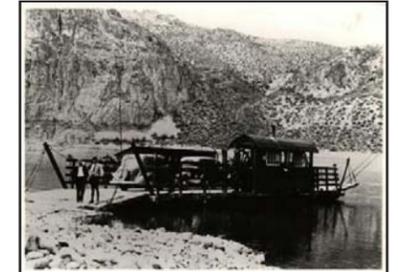
The State of Washington acquired the service and this vessel, the "Keller" in 1931. The Keller was in service until 1939.

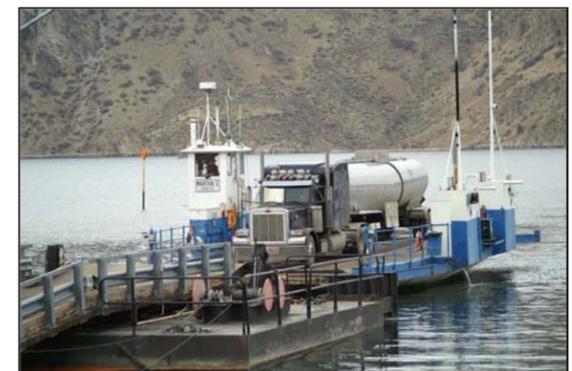
Trucks up to 80,000 lbs. and no longer than 75 feet can cross the river using the "Martha S." Double trailers must be hauled one at a time, requiring the driver to deadhead back for the second unit. Heavier trucks must detour over mountain passes.

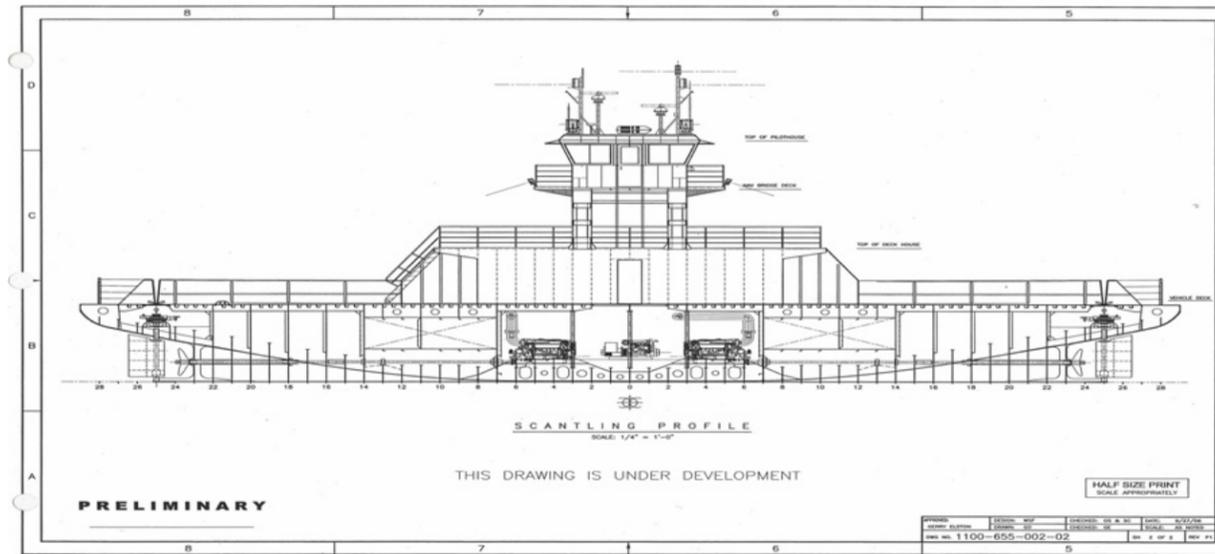
REPLACEMENT VESSEL

- Carry a legally loaded semi-truck
- Remain below the 100 ton vessel class
- Be operated by a crew of two (Pilot and Deckhand)
- Meet current USCG standards
- Key element is the Two-Compartment Damage stability requirement
- Able to operate in all weather conditions and water conditions, including passage through ice, wind and strong currents
- Provide adequate service for current traffic volume needs
- Use existing floating terminals
- Maintain reliability for 60+ years

- Meeting the floatation needs of a legally-loaded truck determined the vessel length and beam. That resulted in the ability to carry up to 20 passenger vehicles
- Greater passenger carrying capacity was not a design criteria, rather a result of the combination of the truck weight, truck length, and flotation required.
- Deepening the hull to regain needed floatation of a shorter, narrower boat cannot be accommodated with the existing terminal design due to the slope of the shore ramps.

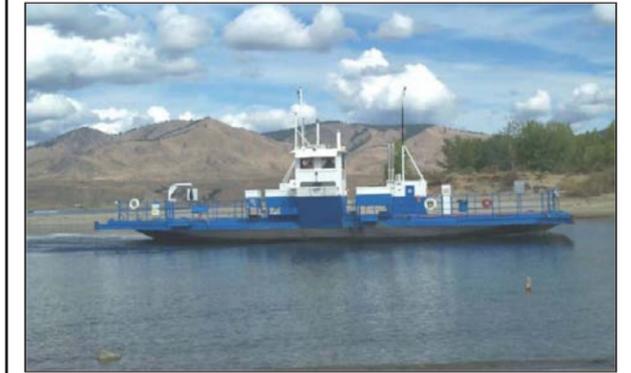
CURRENT VESSEL

Current Boat - The "Martha S." - Placed in service September 1948

- The vessel does not meet current Coast Guard requirements
- Does not meet "Two Compartment Damaged Stability" standards
 - If vessel is fully loaded and more than one compartment is flooded, the vessel may sink.
- The Pilot's full view of the vessel and the waterway is obstructed by standard size RV's and freight trucks
- Currently "grandfathered" to operate
- Equipment age and reliability
- Hull leakage in October 2009
 - Subsequent repairs required two service interruptions-One for 10 days and the other was 30 days.
- Control failure
 - In June 2009, an equipment failure would not allow the operator to engage the gears. The vessel was adrift with passengers.

- Many parts are no longer available and must be custom-made, which causes delays in repairs and is expensive.
- Engines require more frequent overhauls due to age.
- No access to engine compartment with vehicles on the car deck.
